KNOCK ON WOOD

Research details how X-ray fluorescence technology could be the most suitable option for the sorting of recovered treated wood waste.

BY
 HELENA SOLO GABRIELE, PH.D., P.E.
 TIMOTHY TOWNSEND, PH.D., P.E.
 AND HASAN ABDEL FATTAH

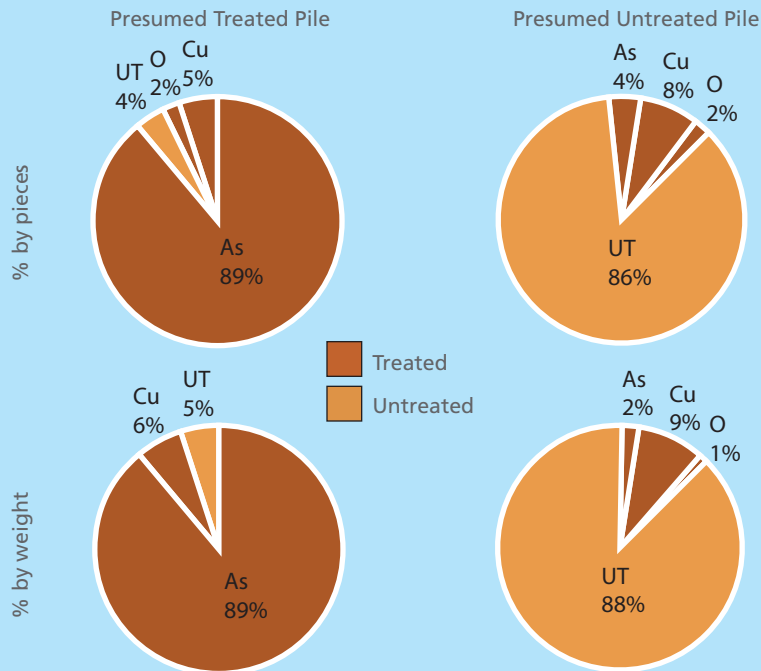
Figure 1 | Composition of presumed treated and presumed untreated pile of 50-percent contaminated infeed wood pile

experimentation. One set consisted of an infeed composition of 50:50 (50-percent untreated wood and 50-percent treated wood), with the other set consisting of a 95:05 makeup (95-percent untreated wood and five-percent treated wood). The 50:50 infeed was used to more adequately observe sorting efficiencies, given the significant fractions of both treated and untreated wood. The 95:05 infeed most likely represents the infeed at recycling facilities that practice visual sorting of C&D wood waste. Experimental results showed that commercially-motorized belt conveyor speeds ranging from 50 to 100 feet per minute can be used for on-line wood sorting via XRF technology. Sorting efficiencies of the 50:50 infeed were found to be between 92 percent and 99 percent for removal of As, between 90 percent and 97 percent for the removal of Cr and between 75 percent and 92 percent for removal of Cu.

By analyzing the two separated piles after the detection and sorting process, researchers found that the presumed treated pile, which is to be diverted to landfill, consisted of between 72-percent to 97-percent treated wood and four-percent to 28-percent untreated wood, with figures being based on both the number of pieces and weight (80 percent to 97 percent and three percent to 20 percent). The presumed untreated pile, which is to be recycled for mulch or energy production, consisted of 78-percent to 86-percent untreated wood and 14-percent to 22-percent treated wood, with figures being based on both the number of pieces and weight (75 percent to 88 percent and 12 percent to 25 percent). Figure 1 shows the wood distribution in the presumed treated and presumed untreated piles for one of the experimental runs (50:50 infeed, belt speed = 0.25 meters per second, feeding rate = 20 pieces per minute). Figure 2 shows results for the same experiment with a 95:05 infeed.

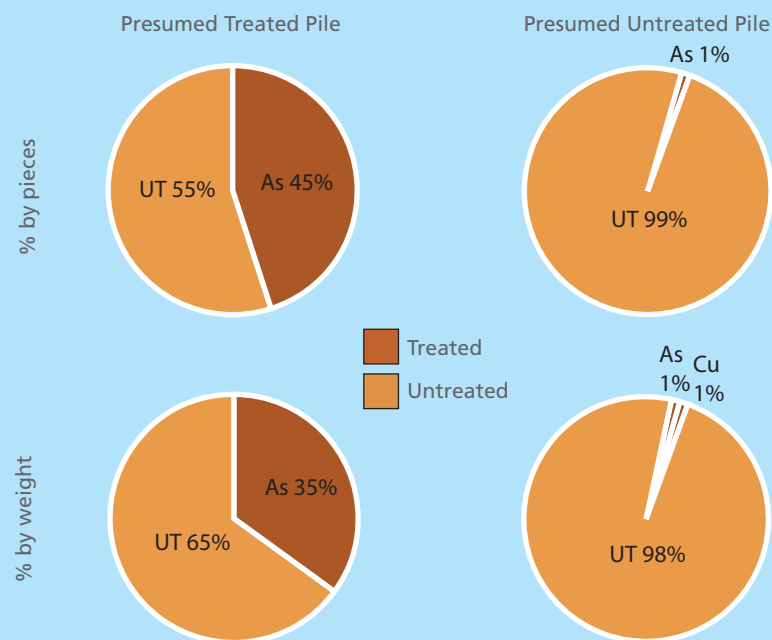
Figure 2 | Composition of presumed treated and presumed untreated pile of five-percent contaminated infeed wood pile

As noted, sorting efficiencies for the 95:05 infeed were observed at 81 percent to 96 percent for arsenic, 80 percent to 96 percent for chromium and 72 percent to 91 percent for Cu. By analyzing the two separated piles after the detection and sorting process, researchers found that the presumed treated pile consisted of 35-percent to 57-percent treated wood and 43-percent to 64-percent untreated wood, with figures based on both the number of pieces and weight (32 percent to 52 percent and 48 percent to 68 percent).

The presumed untreated pile consisted of 98-percent to 99-percent untreated wood, and one-percent to two-percent treated wood, with figures based both on the number of pieces and weight (98 percent to 99 percent and one percent to two percent).
